FINAL REPORT 2016/952

**Understanding interactions between basecutters
and other forward-feed components with the cane
stalk and determining practical strategies to
minimise damage as harvester speed increases**

FINAL REPORT PREPARED BY	Chris Norris and Floren Plaza
CHIEF INVESTIGATOR(S)	Chris Norris (NorrisECT) and Floren Plaza (QUT)
RESEARCH ORGANISATIONS	Norris Energy Crop Technology, Queensland University of Technology
CO-FUNDER	Australian Department of Agriculture, Water and the Environment
DATE	2 April 2020
KEY FOCUS AREA (KFA)	4. Farming systems and harvesting

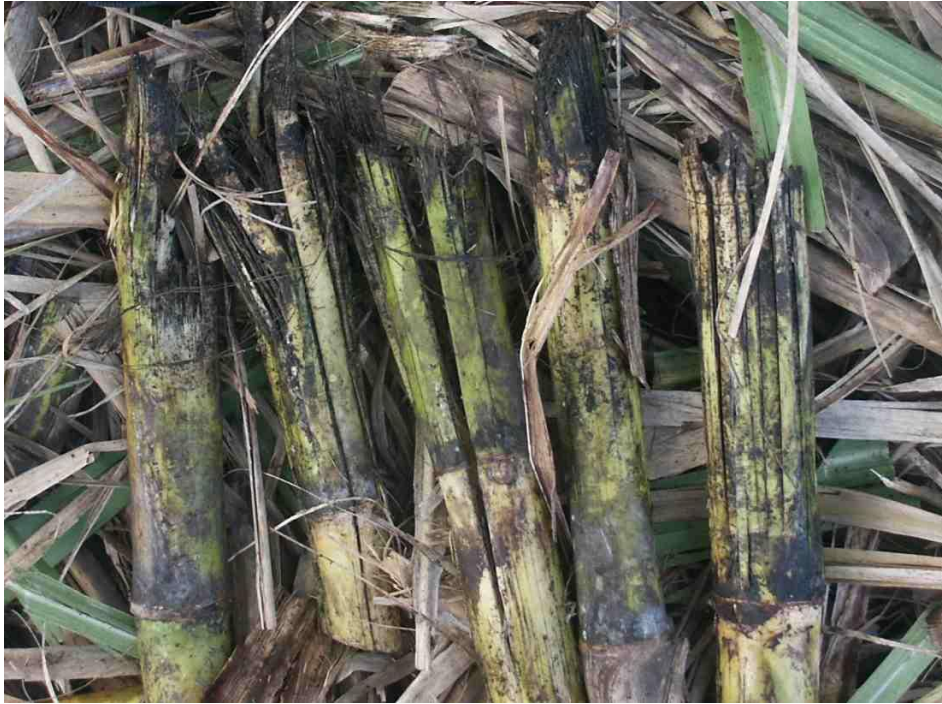
Photograph 5: Damage typical of that caused by the basecutting action.

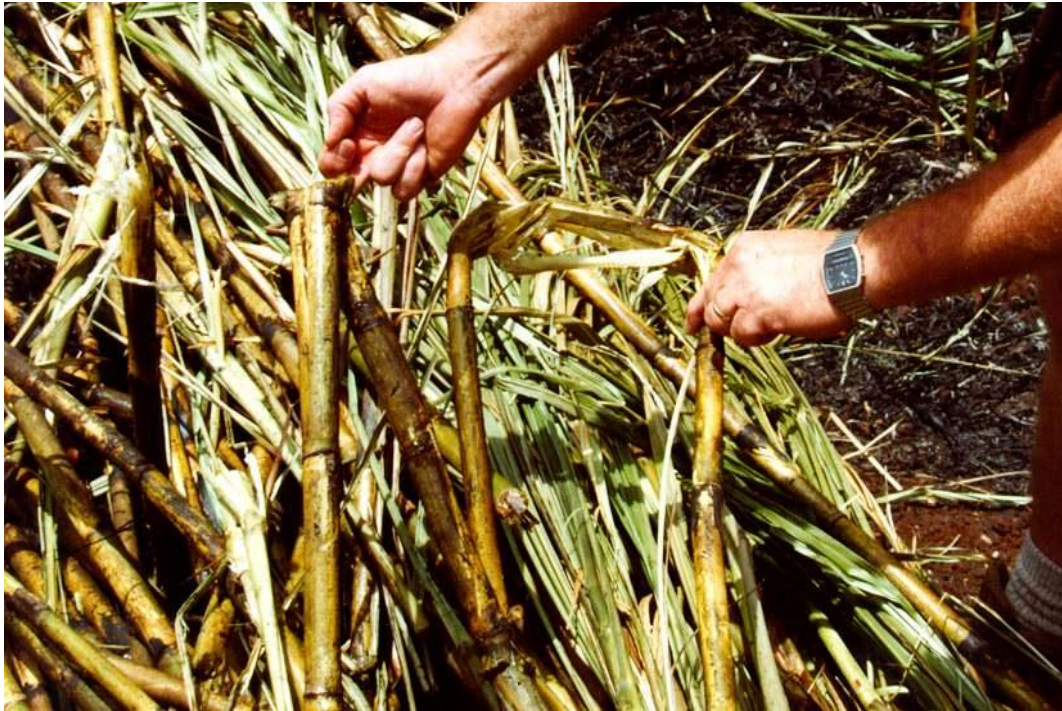
Photograph 6: Stalks split and damaged during the gathering/aligning process result in damaged and mutilated billets.

Photograph 6 illustrates damage to the cane stalk during the gathering and aligning process. This type of damage to the cane stalk results in mutilated billets & billet parts in the final product.

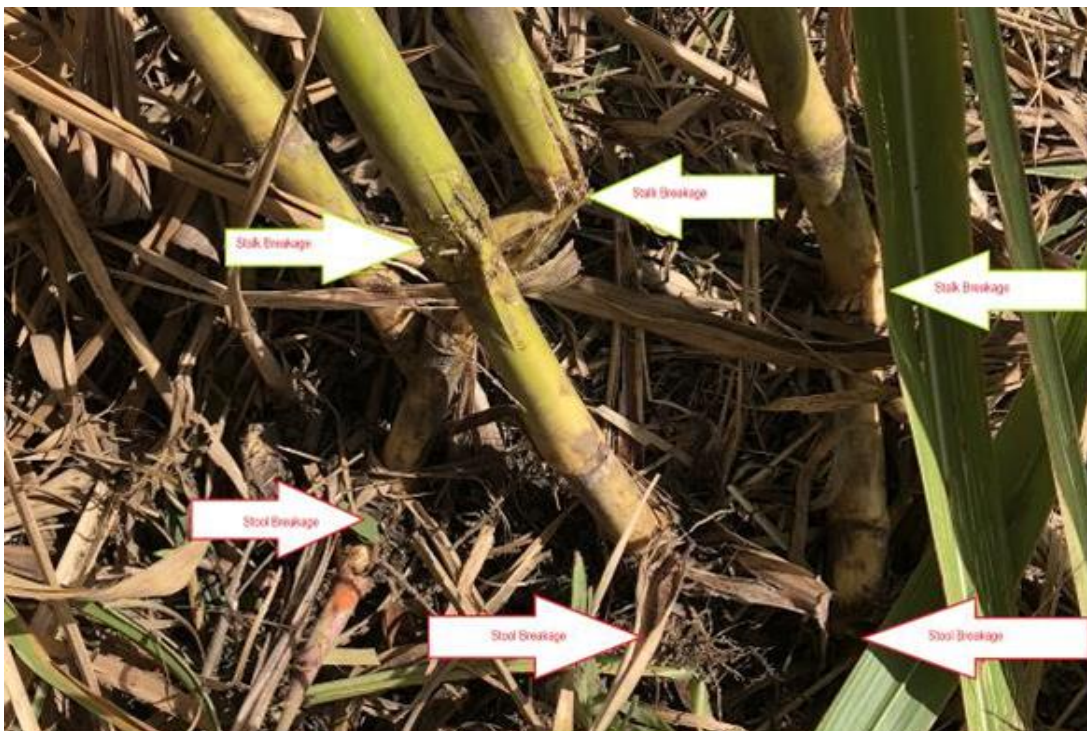
Photograph 7: Stalk damage at ground level and at 15-20 cm above ground level associated with aggressive forward feeding. The stalk is forced into the throat of the machine and buckles under compression failure

Additional sources of damage occur when the high tip speed of the forward feed rollers in conjunction with aggressive design of the “teeth” on these rollers result in axial compression of the stalk and failure prior to basecutting. This effect is shown in Photograph 7.

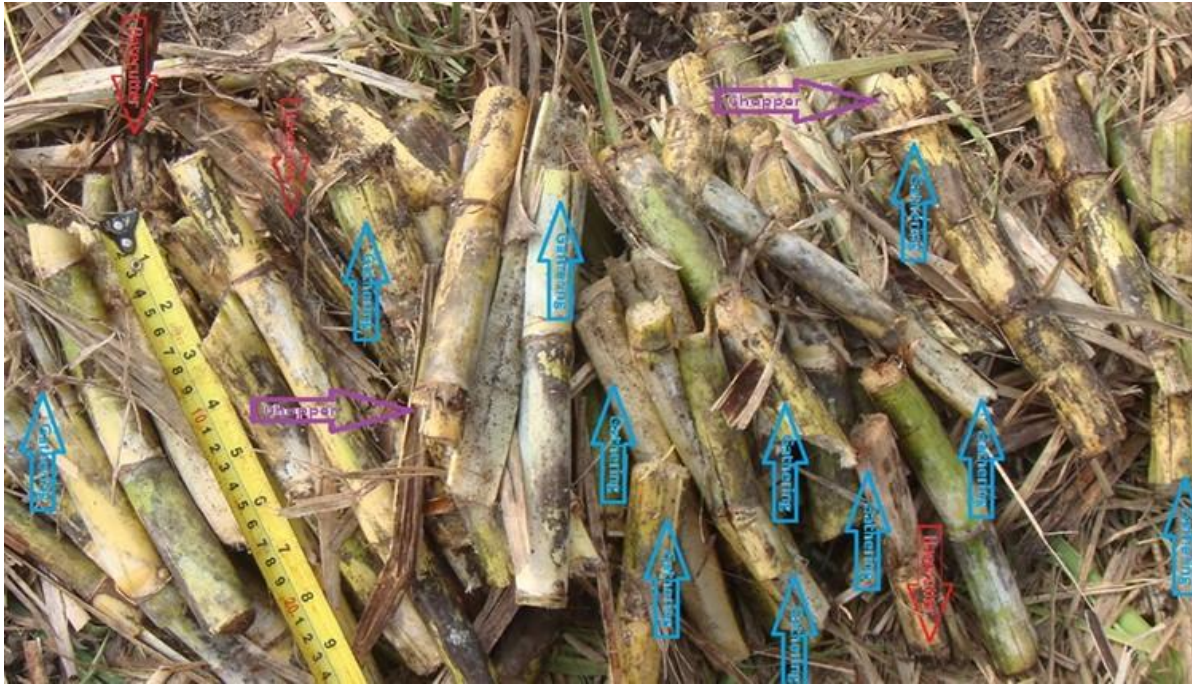
Photograph 8: Billet sample from harvester illustrating the probable source of damage (Gathering, Basecutting or Chopper) observed on billets.

The source of billet damage was determined by analysing the type of damage on the billets delivered by the harvester. Photograph 8 is of a sample of billets from a harvester operating in a heavily lodged crop, with the probable sources of damage identified.

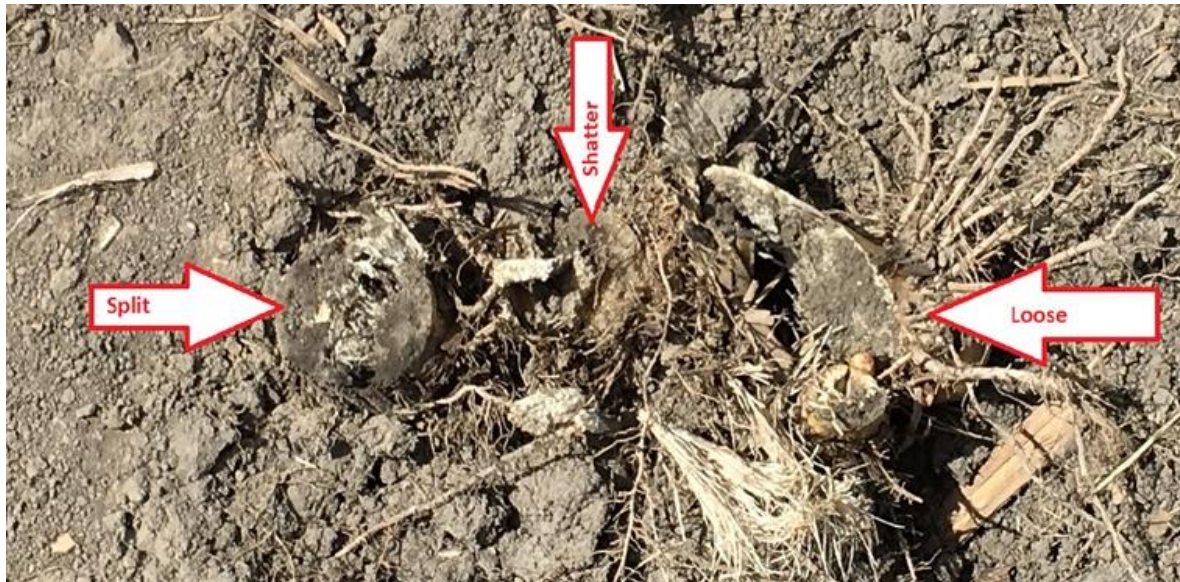
Photograph 11: Illustration of different types of damage in the exposed stool.

Photograph 11 shows examples of the types of stool damage observed after harvest.

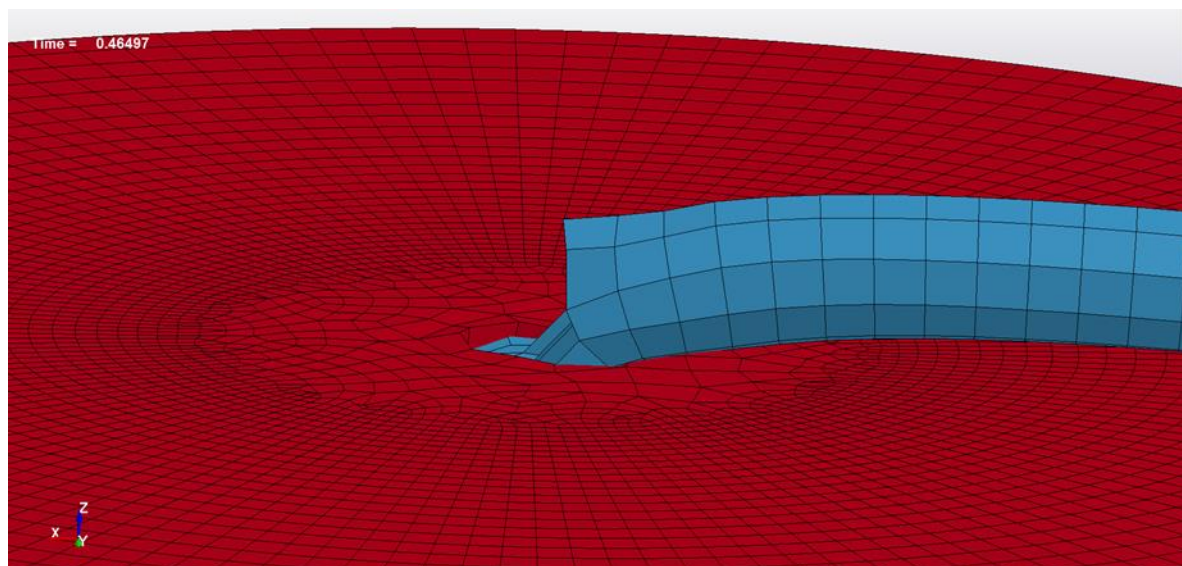
Figure 15: Eventual failure and damage of soft cane by the knockdown roller. Failure is predicted to occur just below ground level.

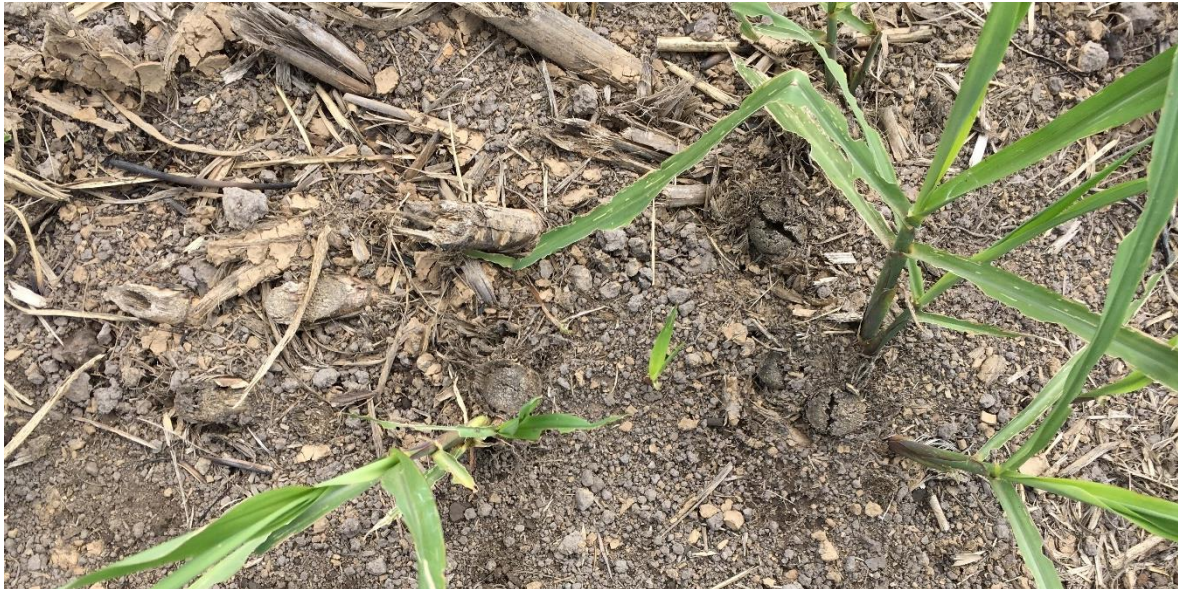
Photograph 15: Ratoon emergence at the BZ farms block. Note the shoot emerging vigorously from a relatively shallow node off the undamaged stump, v's the obviously much deeper nodes associated with the split stump.

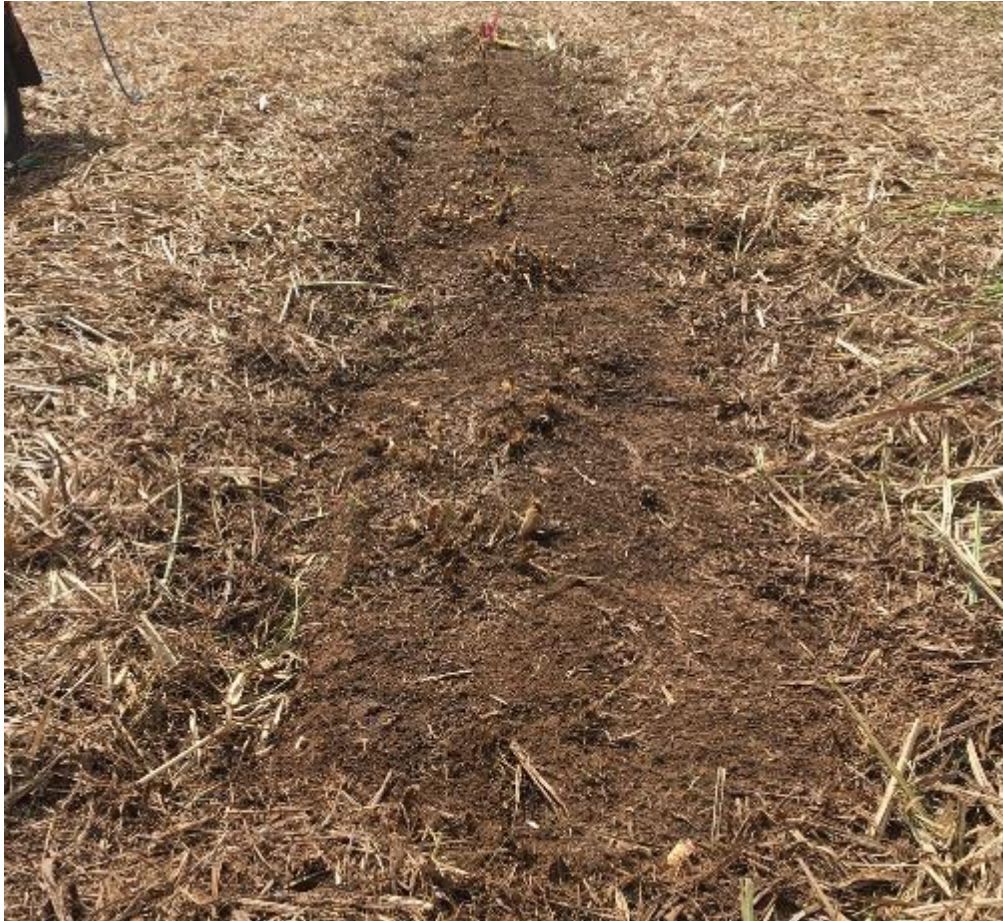
Photograph 19: The row profile at the Plaths Rd trial after the trash and loose soil had been removed.

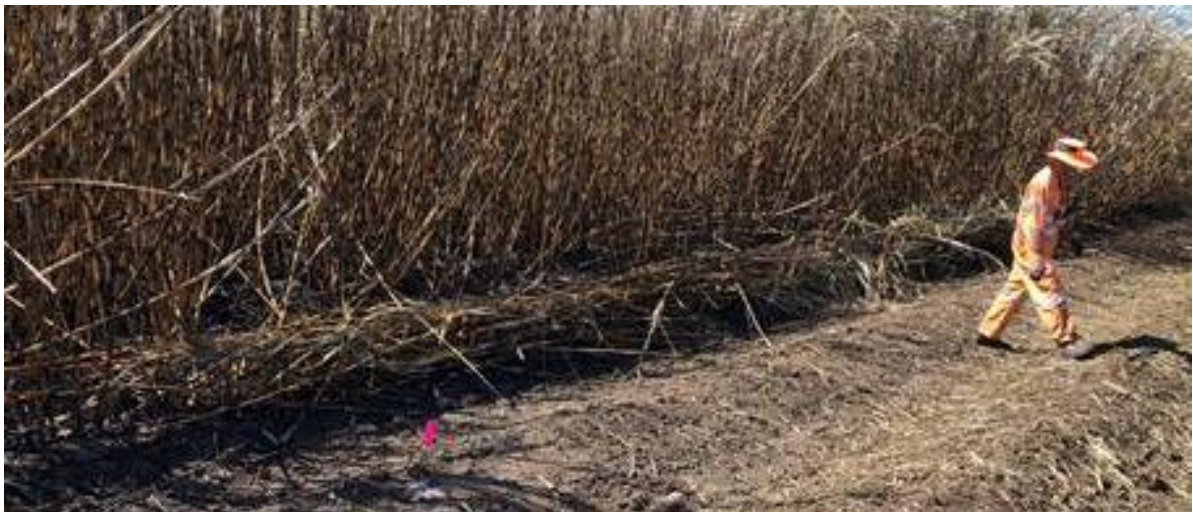
Photograph 22: Sub-plot manually harvested at the Mona Park trial. Note the cane is placed to assist feed and support the stumps from horizontal movement.

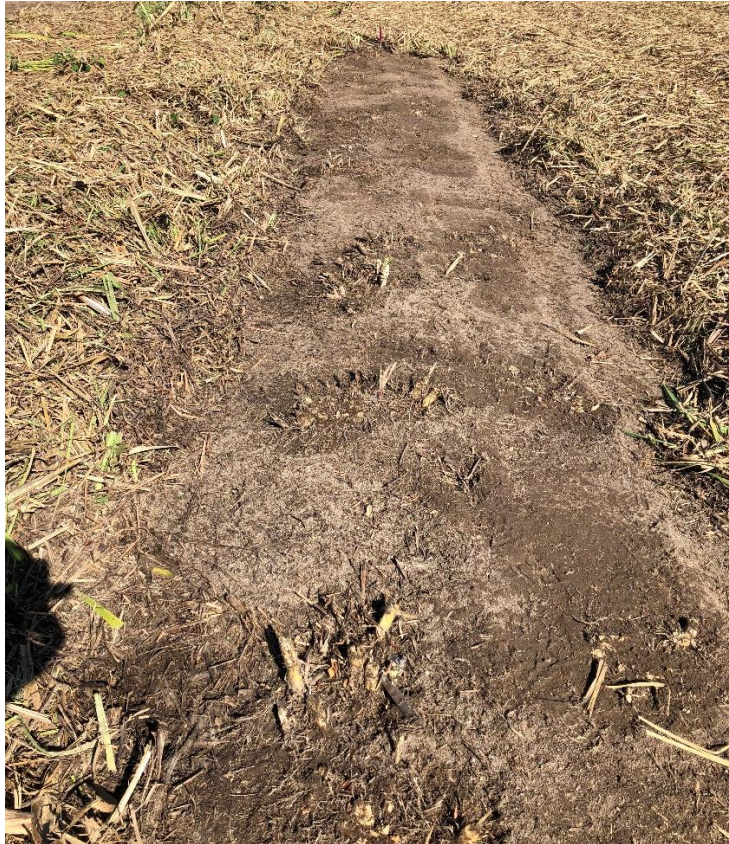
Photograph 25: As the ratoon cycle progresses, the most noticeable effect was the increase in gappiness, derived by the removal of small stools and increase in the size of remaining stools.

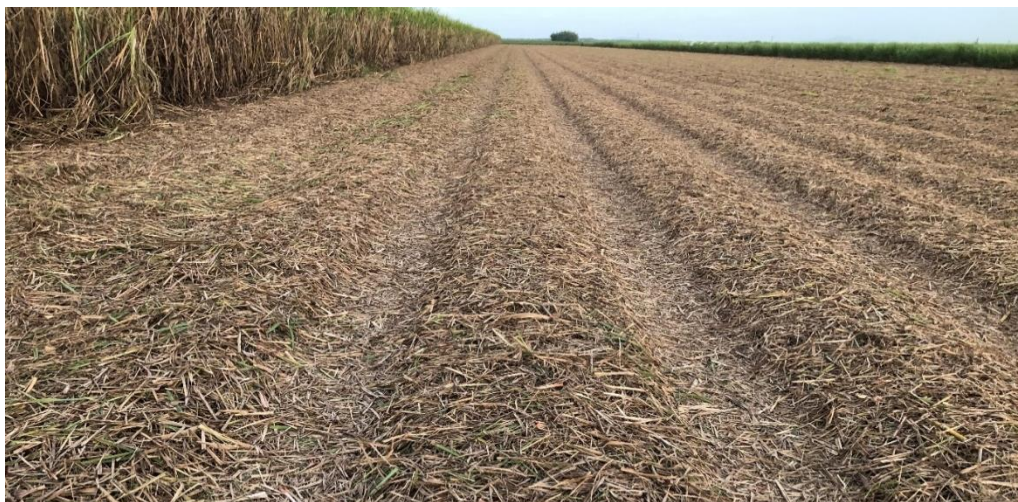
Photograph 31: Control of traffic in the traffic lanes is seen in this field in Guatemala where the harvester and all haulage equipment is operated on GPS, and all machines are set to match the crop 1.9m bed spacing.

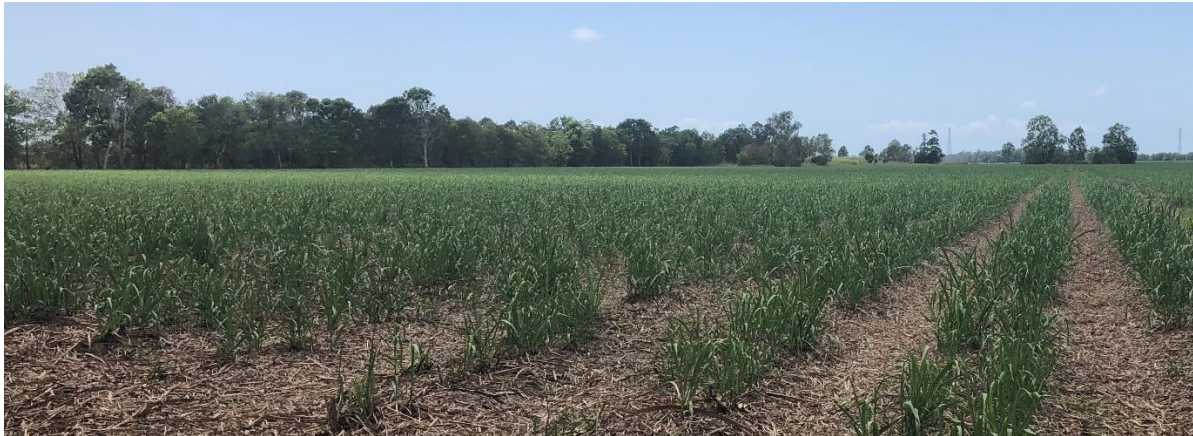
Photograph 32 Matched row spacing and GPS on all equipment have increased ratoon cycle length on this farm, with this photograph being of a 6th ratoon crop.
