# FINAL REPORT 2020/204

## INVESTIGATING THE CORROSIVITY OF EVAPORATOR CONDENSATES AND THE CONTRIBUTING FACTORS

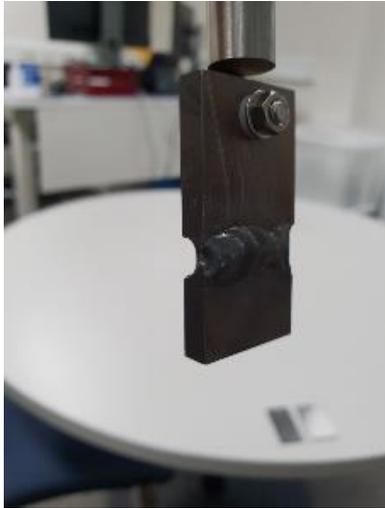
**Figure 5 Welded tube plate (WTP) coupon assembled on the holder**

To test the performance of tube plate material in the vicinity of welded joints against the corrosivity of condensate, 6 mm thick coupons were made from the tube plate material and cut transversely before welding the two sections together. Thicker samples were cut for the trial of welded materials in order to avoid deformation of the coupons during the welding process. Figure 5 shows an example of a welded coupon after assembling on a holder. Only one welded coupon could be attached to the holder because of its increased thickness.

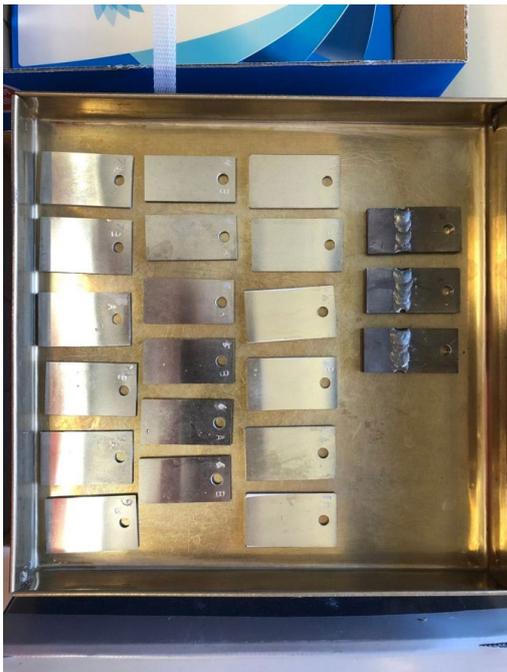
**Figure 6 Degreased and dried coupons ready for installation on holder.**

In order to prevent the coupons from corroding between the time of preparation and the start of testing, the coupons were covered with oil. Prior to assembly to the holders, the coupons were degreased and hot air dried and their mass was recorded. This preparation step was undertaken at the test site just prior to loading the coupons and holder into the rig. Figure 6 shows the entire set of coupons for one mill prior to assembly.

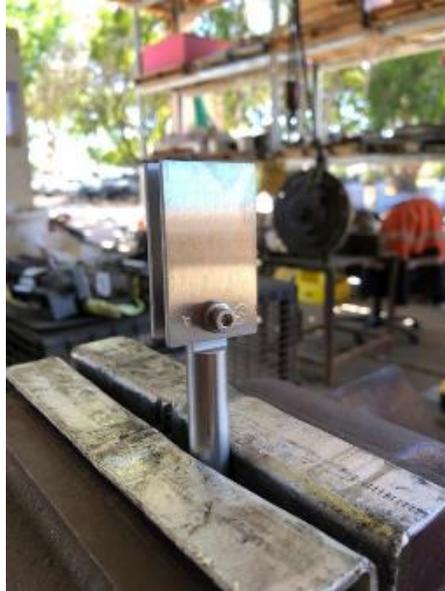
**Figure 7 Coupon and holder assembly.**

For each of the non-welded materials, the two coupons were assembled on each holder using stainless steel bolts and nuts. Nylon washers were used to avoid contact between any two metals. Figure 7 presents an example of a coupon/holder assembly.

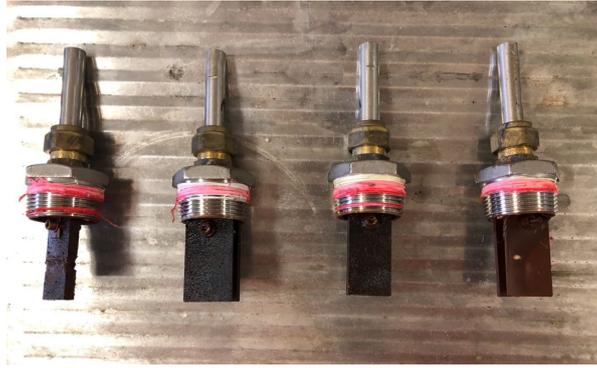
**Figure 9 30-day corroded coupons at Isis Mill.**

The corroded coupons were removed from the manifold at their due time (and new coupons installed if applicable). Coupons were rinsed to clear them of any loose corrosion products and after being dried in an oven, they were kept in a desiccator to prevent further corrosion. Figure 9 shows the 30-day coupons removed from the corrosion rig at Isis Mill.

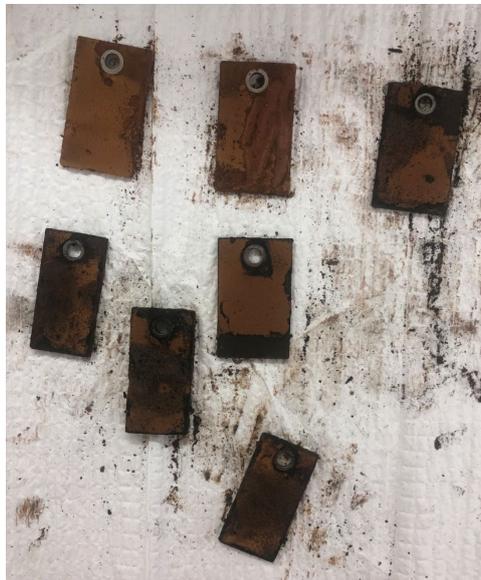
**Figure 10 30-day corroded coupons at Invicta Mill.**

Figure 10 shows a greater presence of corrosion products on the 30-day coupons that were removed from the Invicta Mill installation. Figure 11 shows a substantially thick layer of rust separated from the coupon. The area around the bolt hole under the washer in each coupon experienced no corrosion, confirming that the insulating washer was effective in preventing contact between the coupon holder, connecting bolt and nut.

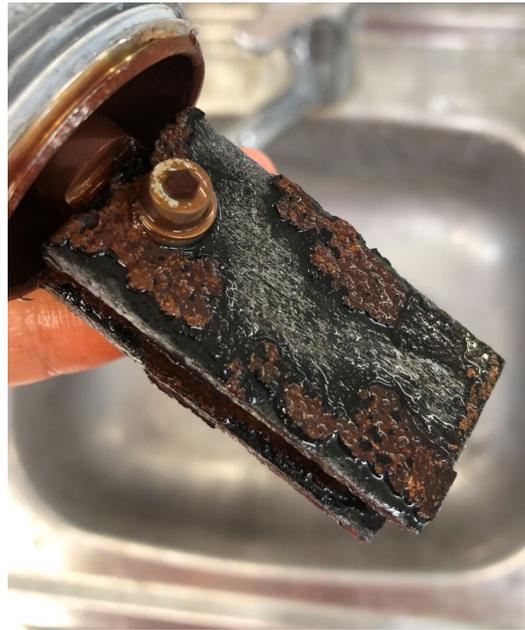
**Figure 14** Tube plate material coupons corroded at Invicta Mill by 60 days of exposure to final condensate.

At the other three factories (Invicta, Pioneer and Condong) the material loss was more consistently spread over the coupon surface indicating general corrosion to be the predominant form of damage. An example is shown in Figure 14 where significant material loss is caused over the entire coupon surface after 60 days of exposure to the final condensate.
